New Entry Sustainable Farming Project
Building the Leopold Center GAP-Certifiable Vegetable Wash Station:
Notes and Modifications - October 2011

A number of modifications were made to the original Leopold Center design for three principle reasons: 1) to use more readily available and/or less expensive materials, 2) to better fit the scale of the small operations that will be using the station, and 3) to attempt to improve the structural integrity of the station components, especially the roof.

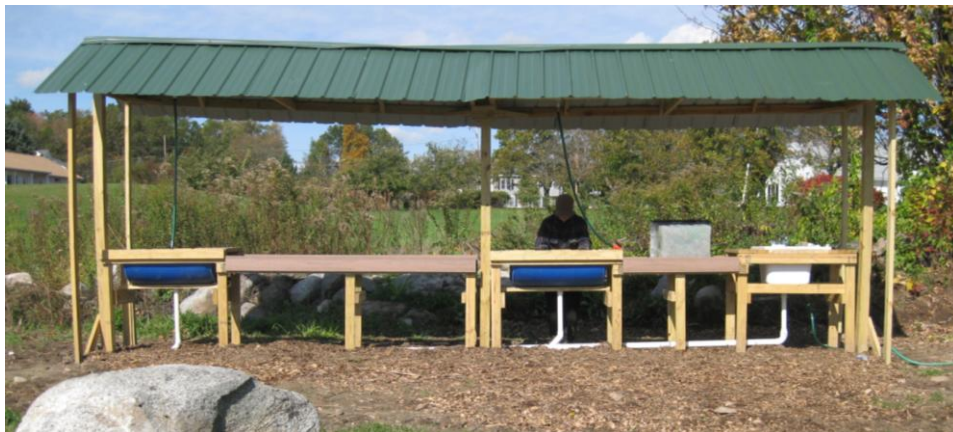
Figure 1. The completed wash station

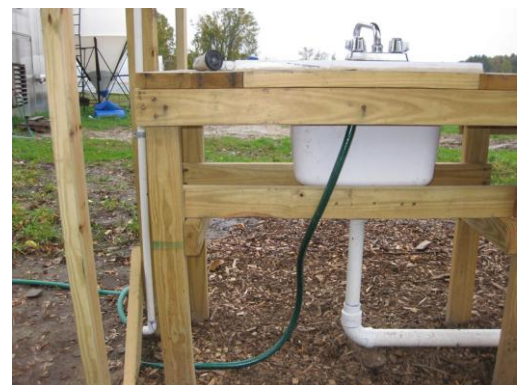
Hand wash sink: The 14.5 gallon plastic utility sink that was locally available was the same width as the sink used by the Leopold Center, but the length and depth were slightly different. Be sure to measure the sink dimensions before constructing the frame. Furthermore, a proper faucet was installed on the hand wash sink in place of the hanging overhead line for user convenience. There is a “Y” splitter at the beginning of the overhead water line that is used to provide water to the faucet via a shortened and mended hose (figure 2).

Figure 2. Hand Wash Sink Water Supply

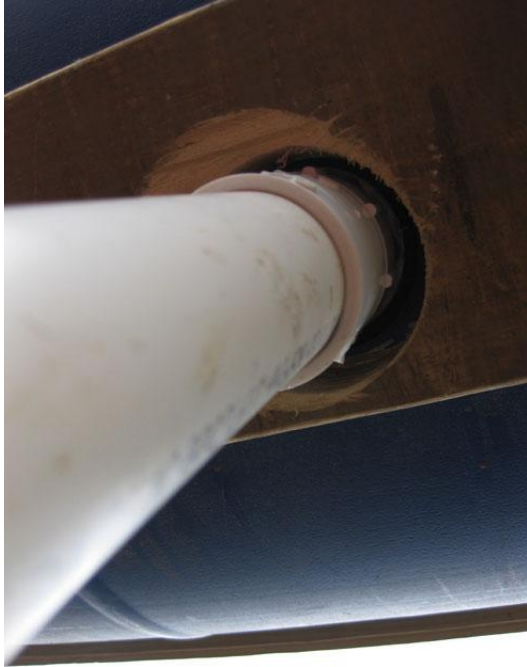
Figure 3. Blue tub drainage

sinks were incorporated into the design instead of just one. As a result, the length of the larger drying rack was extended to make use of the extra space under the roof. As with the hand washing sink, the dimensions of the 55-gallon drum used for the vegetable tubs was slightly wider than the frame dimensions provided by the Leopold Center. Be sure to measure the drum width after cutting it to the desired dimensions before constructing the frame. Finally, a drain hole was drilled onto the bottom of the tub using a 2" hole saw instead of using the bung hole as a drain. This was done in order to allow more water to drain out of the tub without having to install it at an angle. The 2" hole was cut through the 2"x6" support piece and through the tub. After cutting the 2" hole, a 3" hole was cut just through the 2"x6" support to provide more room for the drain plumbing (figure 3).

Achieving effective drainage on the blue vegetable wash tubs also remains a challenge. While the modifications documented above seem to be a significant improvement from the original design, a small bit of water (about ¼ cup) still does not drain because of the slightly elevated lip of the bath tub drain. It might be possible to create a beveled rim around the 2" hole created with the hole saw that would allow the drain to be slightly recessed. Poor drainage would also be an issue if using larger stock tanks in place of the converted 55-gallon drums as the bungholes are slightly elevated and require being tipped to fully drain.

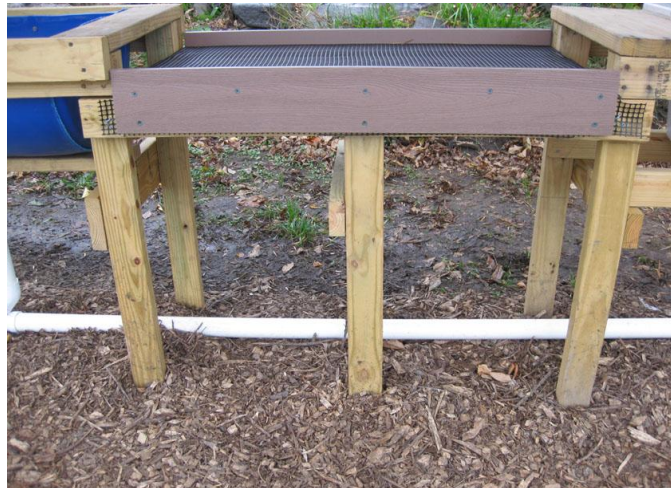
Drying Racks: As mentioned above, the length of the larger drying rack was extended to 94.75" to fill the additional space left by replacing the stainless steel sinks with a second blue tub sink. The adjusted length also reflects a change in the design of the drying rack legs. Instead of just two pairs of legs, one at each end of the rack, an additional 3.5" was left at the end closest to the blue tub sink frame and screwed directly into that frame (see figure 1). The same approach was taken with the smaller drying rack, leaving 3.5" at each end to screw directly into the hand washing sink

Figure 4. Small drying rack legs

frame and the other blue tub sink frame (figure 4). Furthermore, the plastic lumber and mesh designated for use as portable harvest trays in the Leopold Center design was incorporated directly into the design of the drying racks. This was done for two reasons. First, the portable racks seemed prone to breaking through the bottom if they were going to be used for heavy root vegetables. Second, there was some concern that the portable trays would be taken away from the site to the separate distribution location, thus leaving

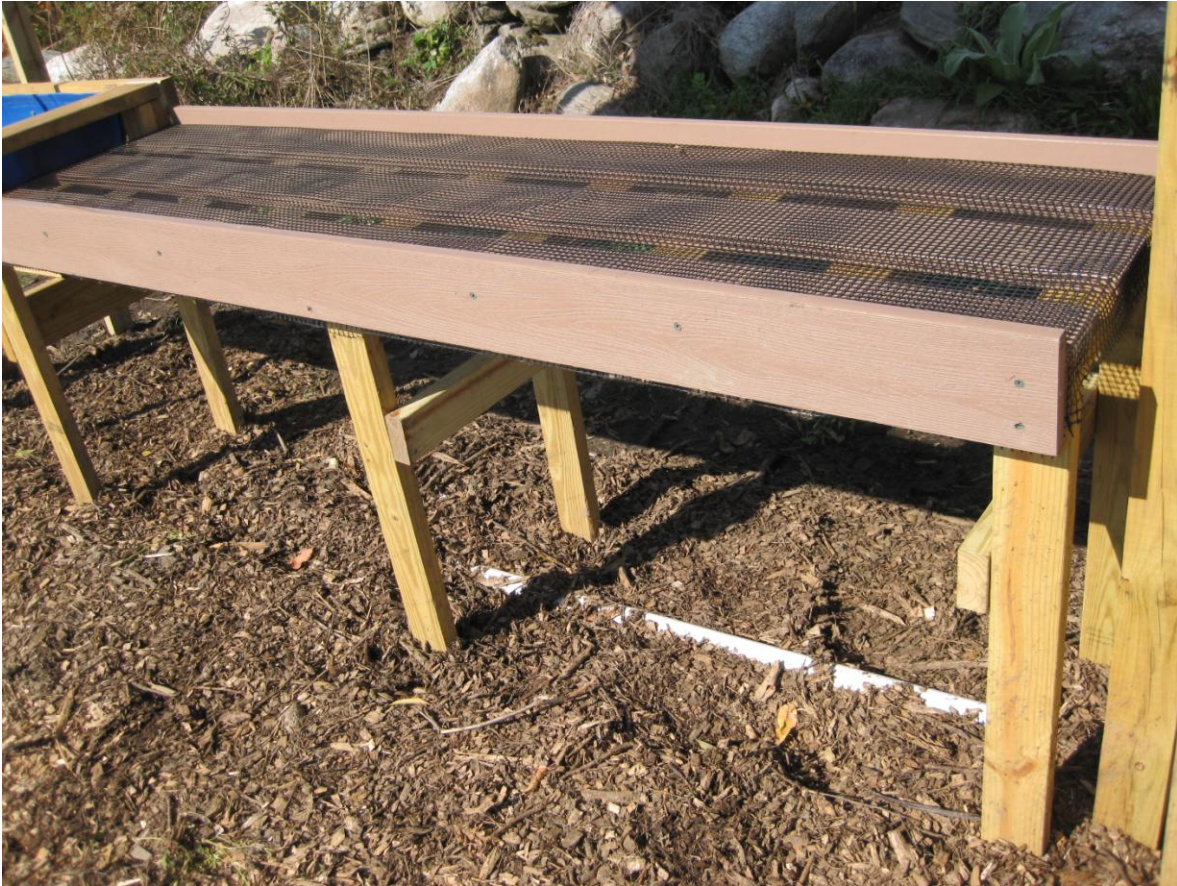
the wash station users with no choice but to place produce directly on the wood frame drying rack (a violation of GAP food safety standards). Three 2"x6" pieces of plastic lumber were screwed directly to the top of the drying rack frames. The black PVC mesh was then stretched over the plastic lumber and attached to the original drying rack frame with $\frac{3}{4}$ " fence staples. Two final 2"x6" pieces of plastic lumber were then attached to the sides of the frame to create a lip and prevent produce from rolling off the racks (figure 5).

Figure 5. Large drying rack with plastic lumber and PVC mesh top

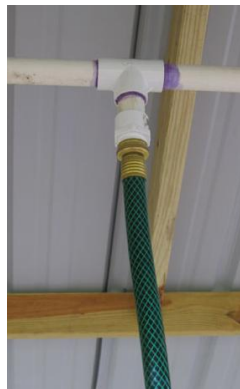
Overhead plumbing: Instead of using poly tubing, New Entry opted to use $\frac{3}{4}$ " schedule 40 PVC for the overhead water line. Threaded male adaptors were attached to the bottom of the two "tees" to provide an attachment point for the shortened and mended garden hoses (figure 6). Also, the PVC supply line was extended down the 4x4 roof support post closest to the hydrant to prevent running a hose up to the line. The female end of the supply hose was threaded into a "Y" splitter, one side of which was then screwed directly into the $\frac{3}{4}$ " PVC female threaded elbow with the other side available to supply the water for the hand washing sink (figure 7).

Figure 7. PVC tee with threaded male adaptor

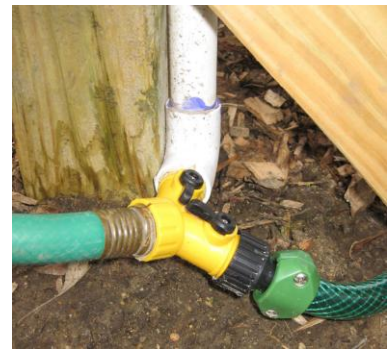
Figure 6. "Y" splitter on supply line

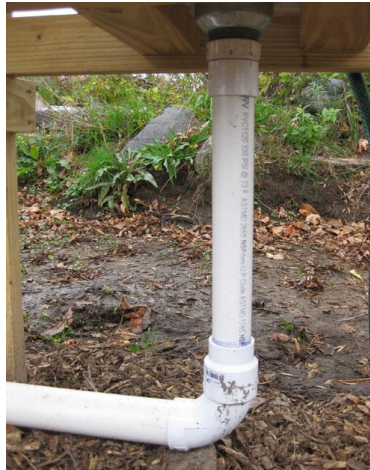
Figure 8. Hand washing sink drain pipes

the three drains. A 1.5" PVC coupler was then attached to the female threaded coupler to provide a female end for the longer 1.5" PVC drain spout. For the hand washing sink, the 1.5" drain spout was attached to a 1.5" to 2" expander coupler before joining a 2" elbow since there were no 1.5" to 2" elbows available locally (figure 8). The 1.5"x2"x2" "tees" used to attach the 1.5" drain spouts from the two blue tub sinks to the main drain line were offset at a 45 degree angle, requiring the use of 1.5" 45 degree angled couplers to tie into the "tees" (figure 9). Standard 2" bathtub drains were used in place of the bungholes for drainage, as discussed above in the "blue tub vegetable wash sinks" section (figure 10). The additional 2" 45 degree couplers and 2" elbow were used to extend the drain line beyond the roof structure. No backflow prevention is needed, since the supply line and drain line are not connected.

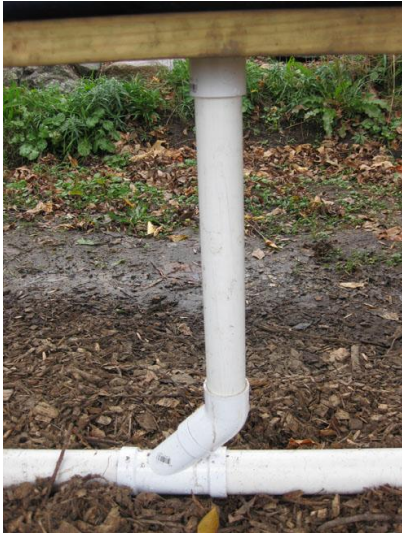
Figure 9. Wash tub drain pipes

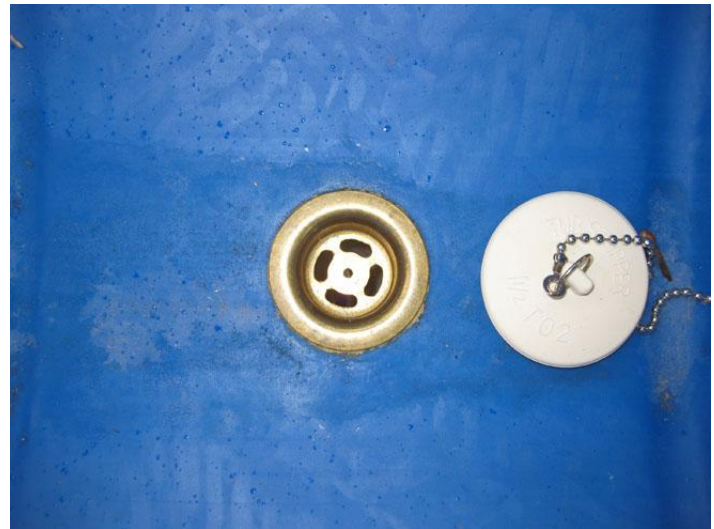
Figure 10. Wash tub drain

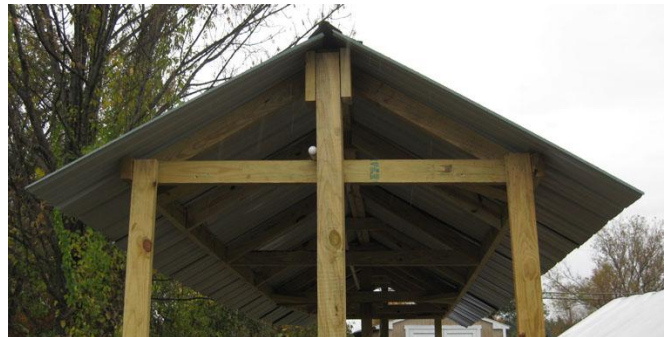
Roofing Material: The original Leopold Center design calls for using 4 12-foot pieces of roof tin to complete the roof. New Entry instead purchased 9, 8-foot pieces then cut them in half with heavy duty tin snips, creating 18 4-foot pieces cut in half. These pieces were then attached to the trusses with the corrugation running vertically to facilitate water runoff. This modification added about 2 feet of covered area lengthwise and about 1.5 feet to the covered width of the structure (figure 11).

Figure 11. Roof tin layout

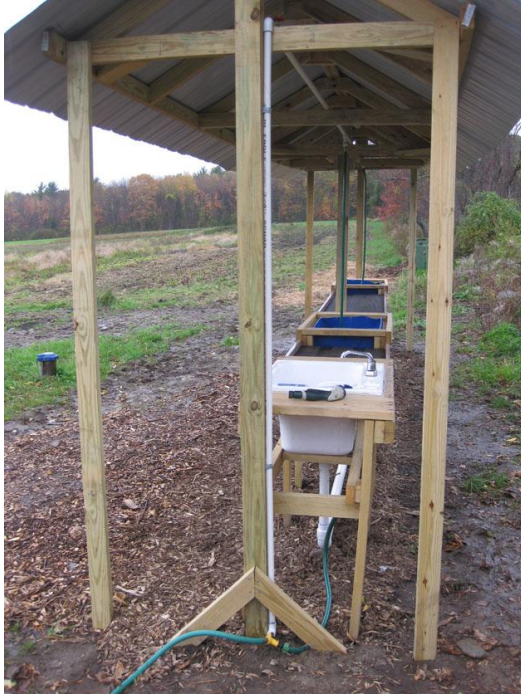
increase the structural integrity of the roof. After installation, there was still excessive play on the roof. This led to the addition of 2, 2x4 supports that screw into the roof trusses at each end of the structure and are buried about 3 inches deep in the ground (figure 12). Extra 45 degree cut 2"x4" pieces were attached to the bottom of the two outermost 4x4 posts and buried 4"-5" underground for additional stabilization (figure 13). The middle 4x4 post was reinforced with 2, 3-foot long 2"x4" pieces screwed to either side of the post and buried about 3" underground.

Figure 12. Corner roof supports

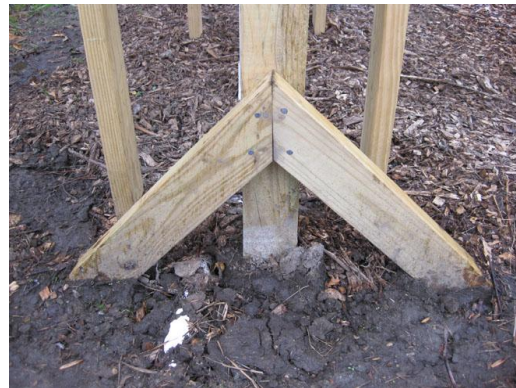
Figure 13. Roof post base support

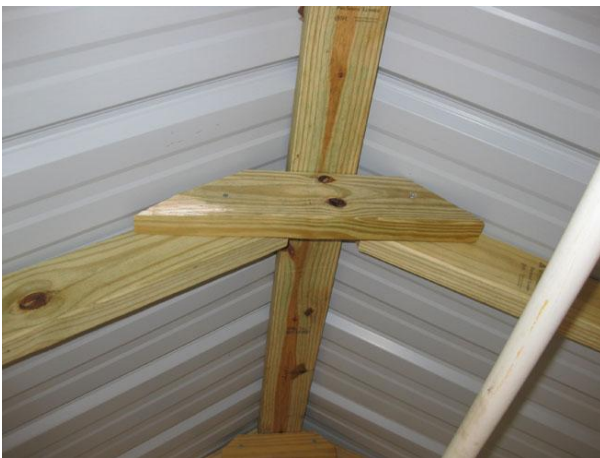
Roof Trusses: The two roof trusses were modified to accommodate the change in roofing material. Two additional rafter beam sets were added to each truss to provide surface area for securing the roof tin. Each set of rafter beams was also attached to a 2"x4" cross piece just beneath the crest for increased stability (figure 14). The rectangular base frame was similarly reinforced with 45 degree cut 2"x4" joists at each of the corners (figure 15).

Figure 14. Rafter cross piece

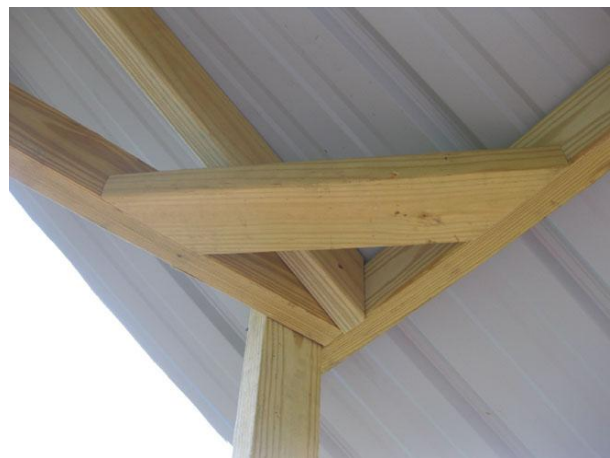
Figure 15. Roof base corner joist
